### Site 353 Old County Road

Great Marsh Coastal Wetlands Restoration Plan  
Rapid Technical Assessment Site 353

## Site 353: Old County Road, Salisbury, MA

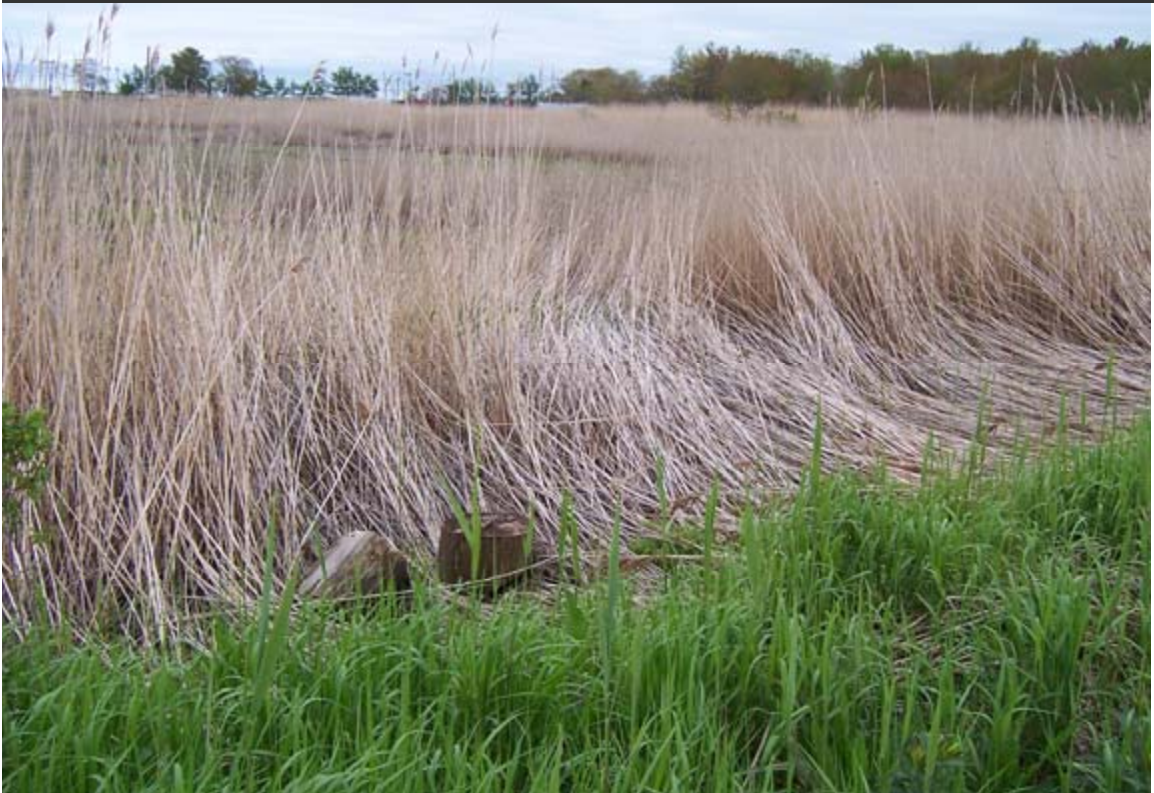
**Photo 1 - Central Portion of Site Viewing South**

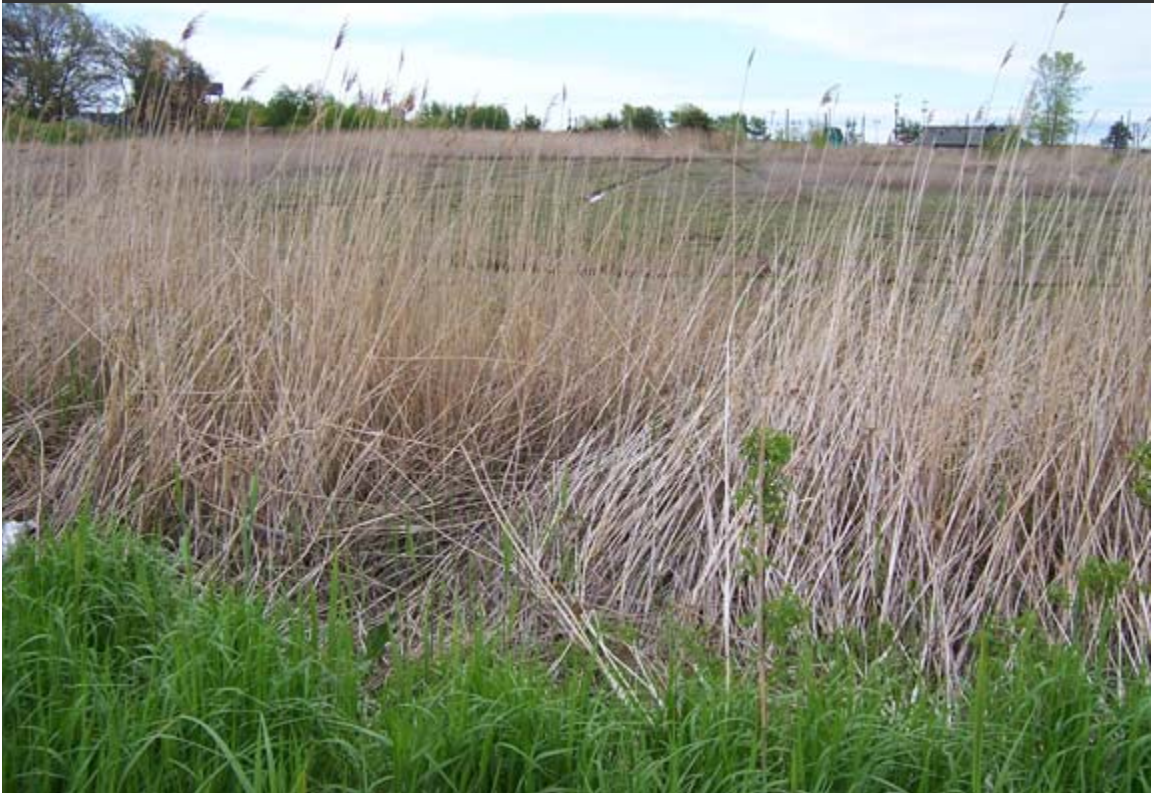
**Photo 2 - Eastern End of Site Viewing South**

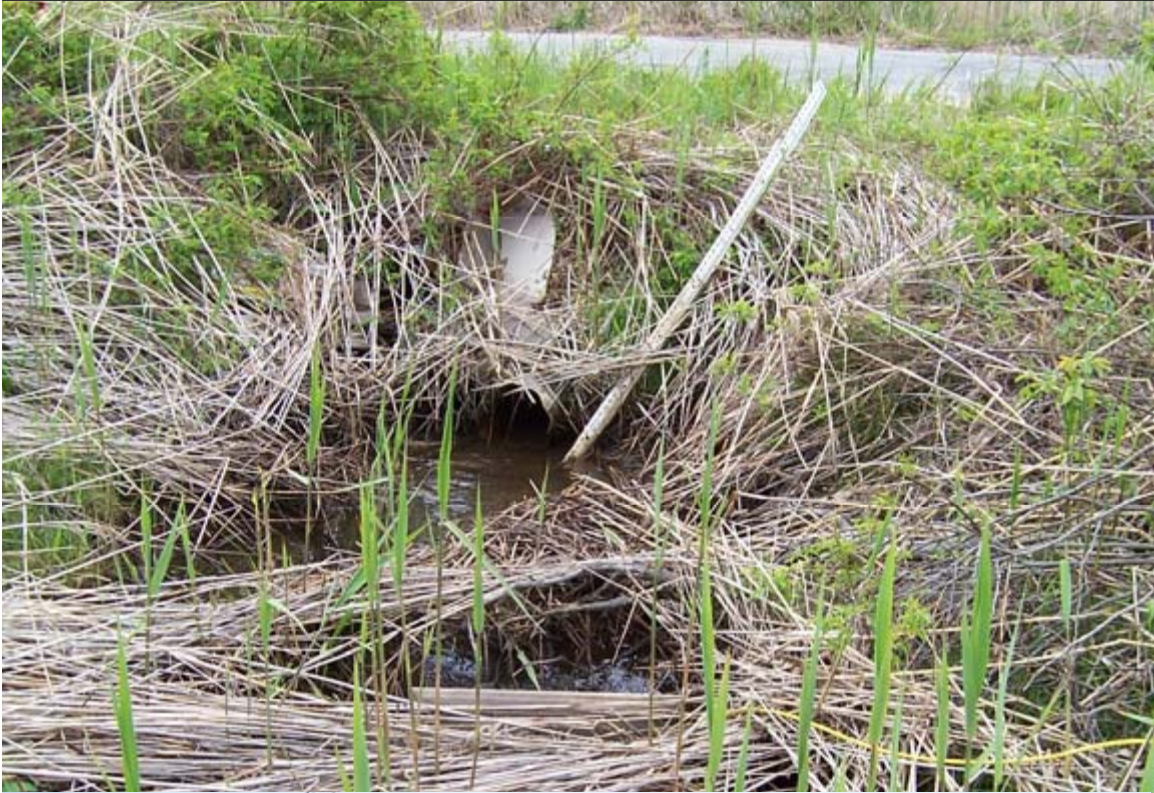
**Structure conditions:** There are a total of four culverts under Old County Road. Three culverts are located in a small ditch at the eastern end of the potential restoration site. Two of the culverts are 12 in CMP pipes and the other culvert is a 10 in CMP pipe. The downstream inverts have no scour protection or headwalls. The downstream invert of the eastern-most culvert (12 in CMP) is severely deteriorated. The upstream inverts of all three culverts are partially buried with sediment. Overall, these three structures are in fair condition. It is recommended that all three culverts be cleaned and inspected further. The fourth culvert is located in the middle of the potential restoration site approximately 150 ft west of the first three culverts. This culvert is a 12 in CMP pipe and is located in a small ditch. There is no scour protection or headwalls at either invert. Also, the downstream invert has become blocked by sediment and debris. Overall the culvert is in fair condition. All four culverts are between 38 and 44 ft in length.

**Photo 3 - Downstream View of Eastern Culvert Crossing**

The overall severity of the existing impairments is considered severe. The replacement of the existing culvert with a somewhat larger structure set lower in the channel would reduce the small tidal restriction and the impounded conditions. Culvert replacement along with substantial ditch cutting/maintenance and OMWM work would be necessary to limit the expansion of the fringing populations of *Phragmites* and effectively control mosquito breeding. No substantial impact to the adjacent forested wetland is anticipated from the restoration activity. There are several low-lying residential properties along Old County Road. With one exception, all buildings are higher than the elevation of the existing road. It is reported that residences surrounding the site intend to

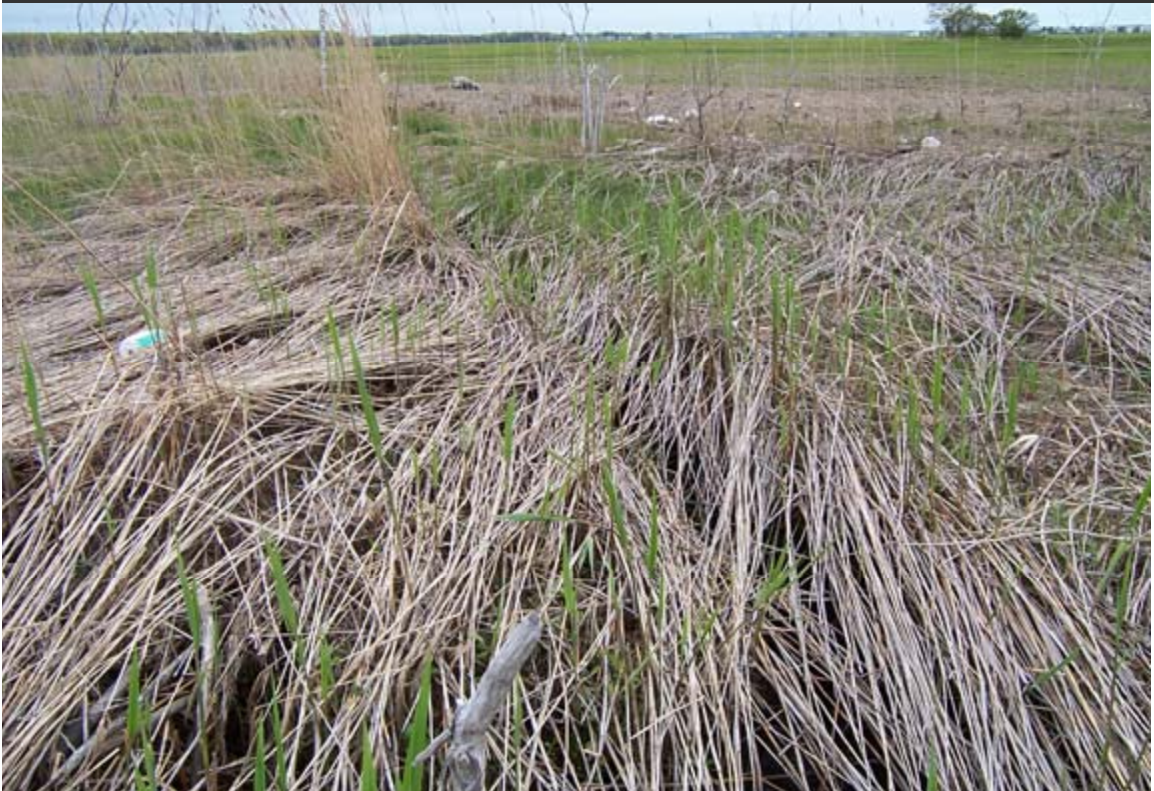
There is also a large stand of *Phragmites* downstream of the road crossing at the base of the adjacent closed landfill. This stand is likely supported by groundwater and possibly leachate flows from the landfill.

**Photo 4 - Salt Marsh Downstream of Road Crossing Viewing North**

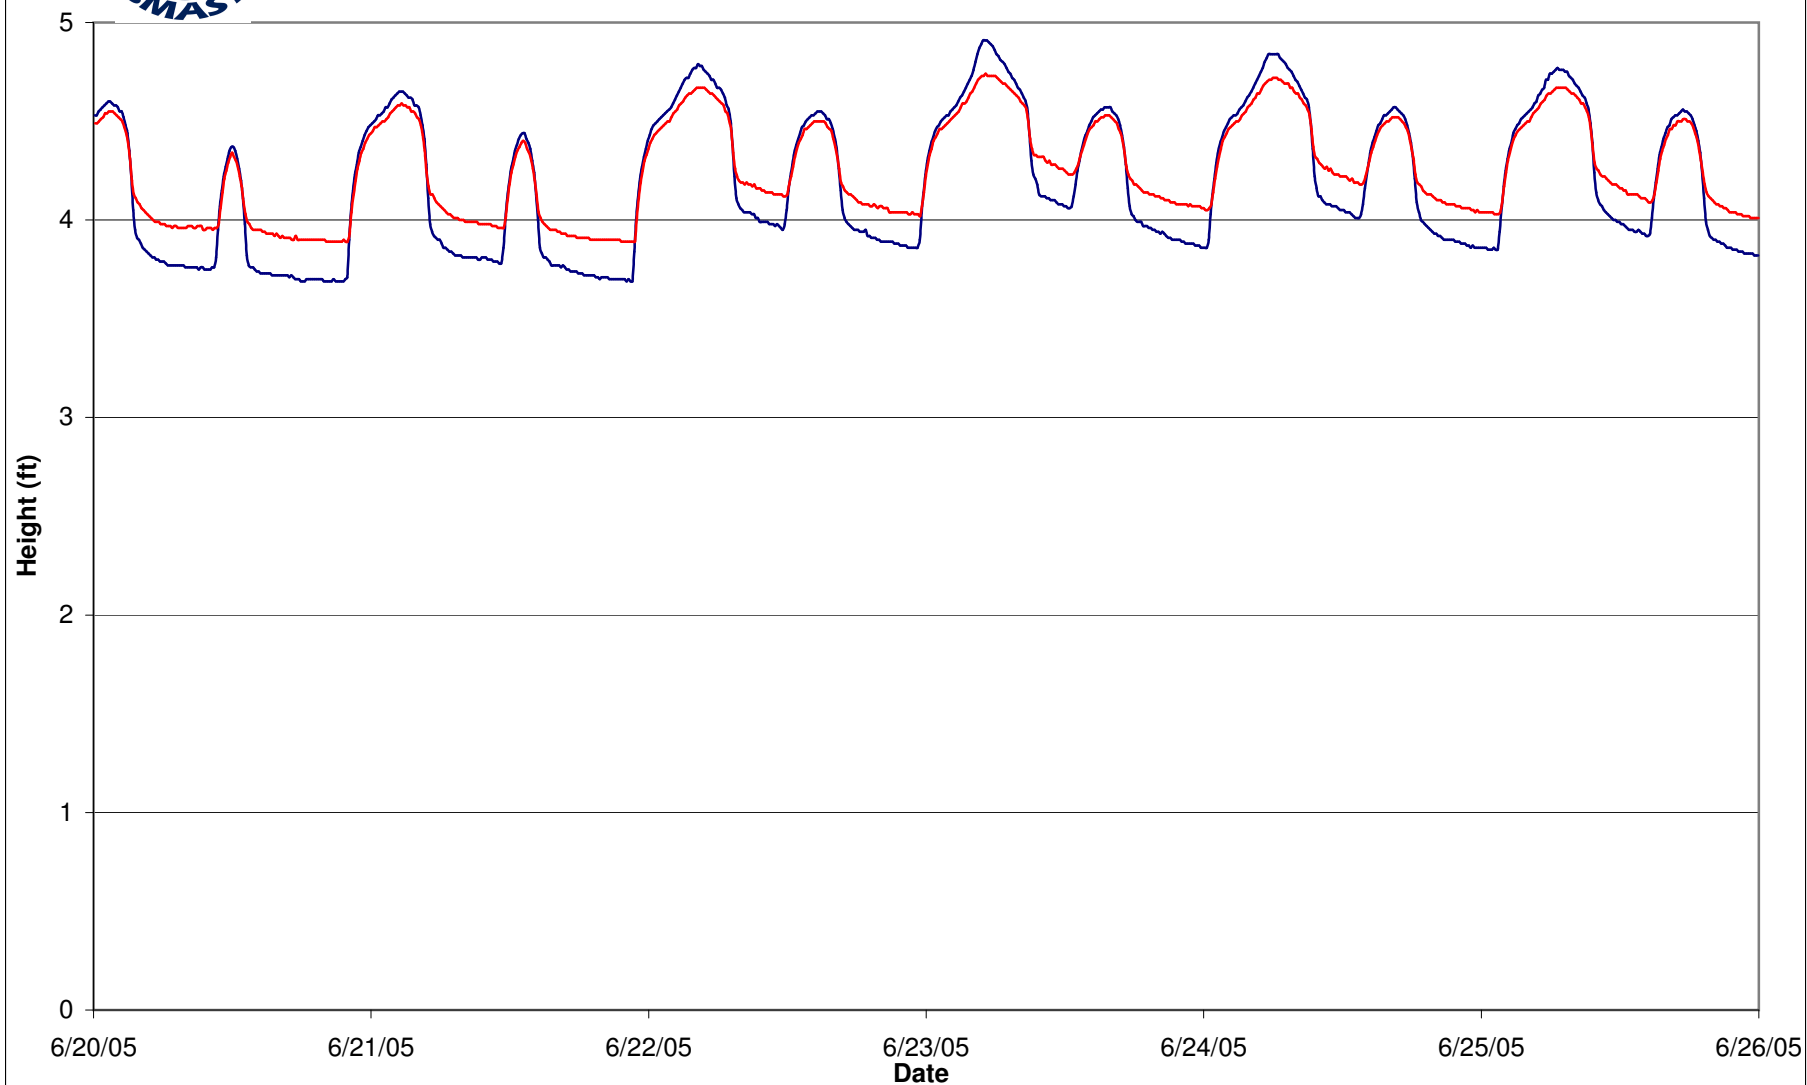
Down Stream  
Up Stream

Two tide gauges were deployed from May 18 to July 8, 2005 upstream and downstream of the series of three culverts under Old County Road. Results of the gauge deployment show a limited restriction of tidal flow through the culvert that increases with the tidal prism increases. Tidal restrictions ranged from less than 0.1 to 0.17 ft and time delays ranged from less than 10 min to 23 min. The highest recorded tide downstream of the culvert occurred on June 23 at 4:56 AM at an adjusted height of 4.91 ft. Upstream high tide occurred at 5:09 AM at an adjusted height of 4.74 ft. The resulting tidal dampening was 0.17 ft. and a delay of 13 minutes. The dampening amounted to approximately 17.9% of the total tidal prism recorded at the downstream gauge. The only larger time delay was 23 min which occurred on June 24 during the morning tide. Relatively low salinities of 3.9 ppt downstream and 3.9 ppt upstream of the culvert were measured at the time of this gauge deployment.

Two tide gauges were previously deployed by WRP staff from May 26 to June 8, 2004 in similar locations. Results of this gauge deployment show a greater restriction of tidal flow through the culvert which increases as tidal prism increases. These restrictions occurred during all of the 24 tidal cycles recorded for this deployment. The highest recorded tide downstream of the culvert occurred on June 3 at 3:49 AM at a comparably adjusted height of 5.02 ft. Upstream high tide occurred at 4:10 AM at an adjusted height of 4.35 ft. The resulting tidal dampening was 0.67 ft and a delay of 21 minutes. The dampening amounted to 32.8% of the total tidal prism recorded at the downstream gauge. The differences in the amount of tidal restriction between the two deployments was likely related to differences in data logger locations. Both deployments show prolonged impounded conditions.
